## 30. SECURITY DOORS AND WINDOWS

## 31. SHUTTERS

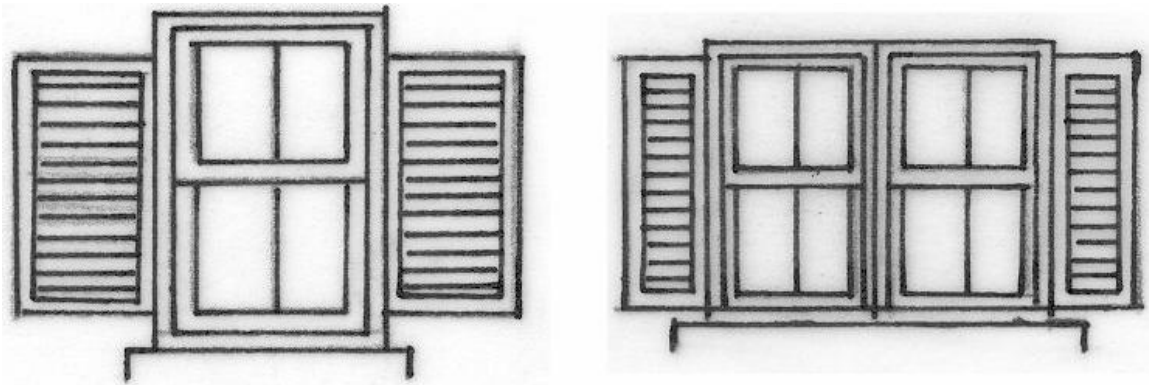
Inappropriate Shutters- would not fit windows if closed

- A. which are original to the dwelling should be preserved and maintained.
- B. should not be added unless the building originally had them, the shutters are of louvered wood construction or another historical style, and the shutters will fit the window opening (so that if closed, they would cover the window opening).
- C. of vinyl construction are not permitted. These shutters generally have exaggerated wood graining, which is not convincing or compatible with historic dwellings.

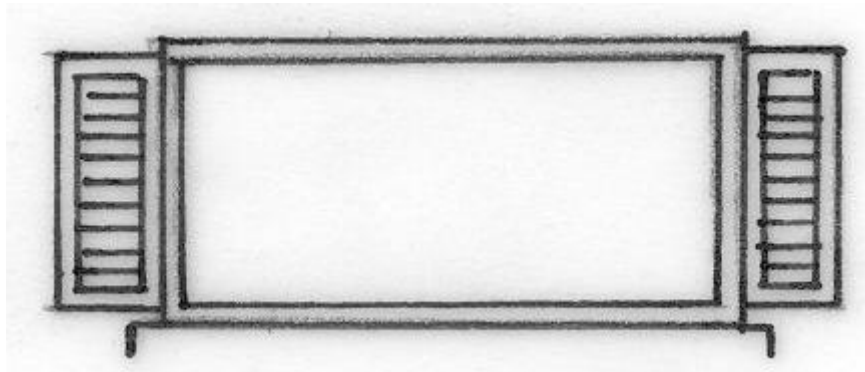
Inappropriate Shutters

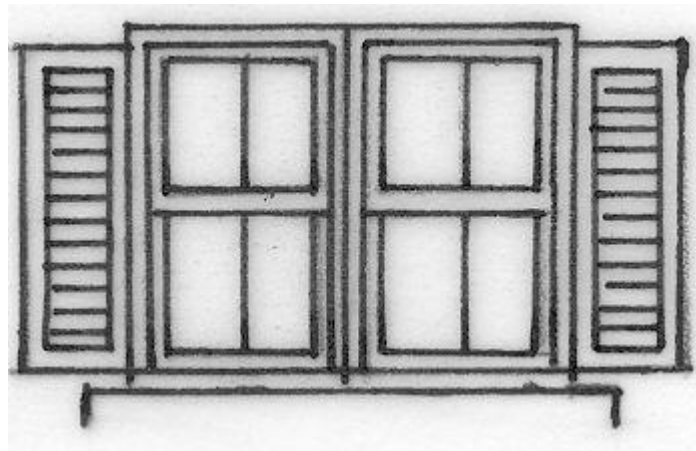
Inappropriate Shutters

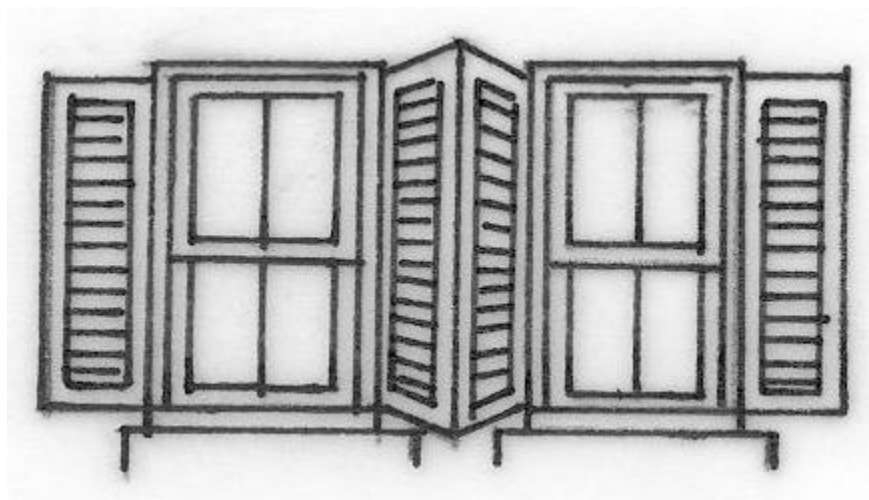
Appropriate Shutters would cover windows when closed
